CANEADEA DAM

ALLEGANY COUNTY, NEW YORK
INVENTORY NO. 484

PHASE I INSPECTION REPORT
NATIONAL DAM SAFETY PROGRAM

PHASE I INSPECTION REPORT
NATIONAL DAM SAFETY PROGRAM
CANEADEA DAM, INVENTORY NO. 464
CANEADEA CREEK, GENESEE RIVER BASIN
ALLEGANY COUNTY, NEW YORK

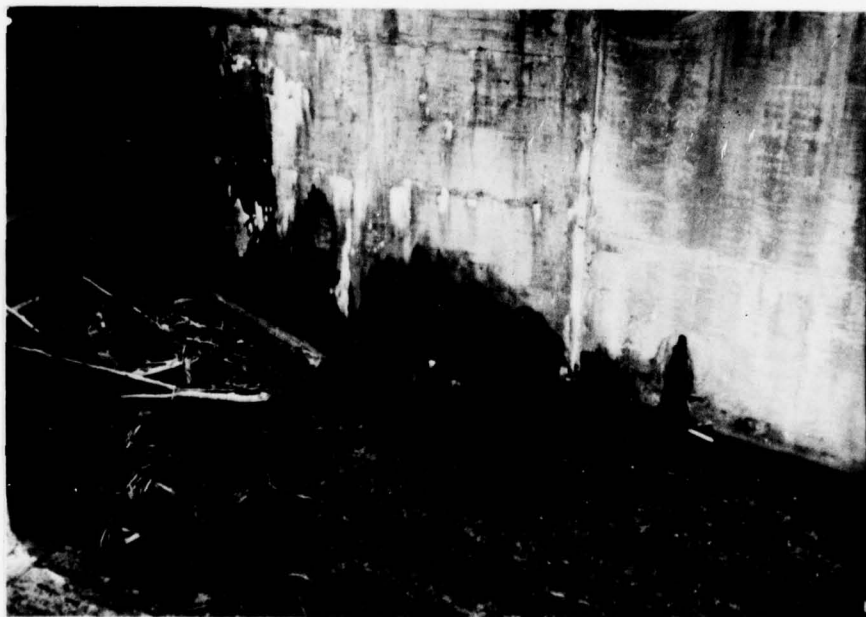
DOWNSTREAM VIEW AT BOTTOM OF LEFT SPILLWAY GATE INCLUDING
WEEP HOLE DISCHARGE

- 3) An attempt should be made to clean inoperative weep holes in the spillway channel.
 - 4) Initiate a program of rehabilitation of concrete structures with exposed rebars and spalled or eroded surface areas of walls and slabs. Priorities for repair would depend upon the severity of damaged concrete.

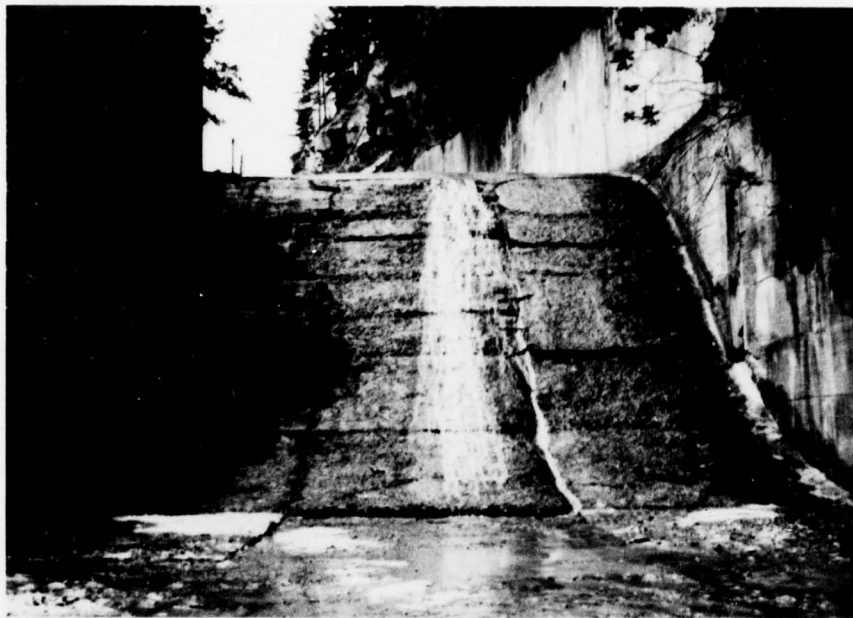
There is substantial erosion on the downstream portion of the sloping chute floor. The flatter floor slab near the abrupt end is also badly eroded. At the downstream end of the high right wall where the chute slab drops sharply there is some local undermining - a chunk of concrete several cubic feet in volume is missing.

CHUTE AT DOWNSTREAM END OF SPILLWAY CHANNEL

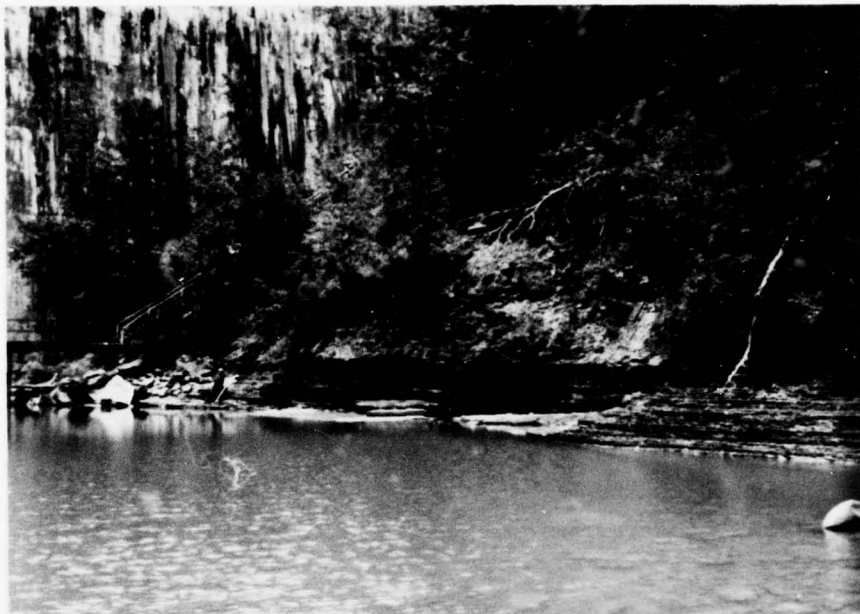
Seepage was also observed coming from the downstream face of the north (left) concrete abutment.

AREA OF SEEPAGE ON LEFT SIDE DOWNSTREAM OF DAM

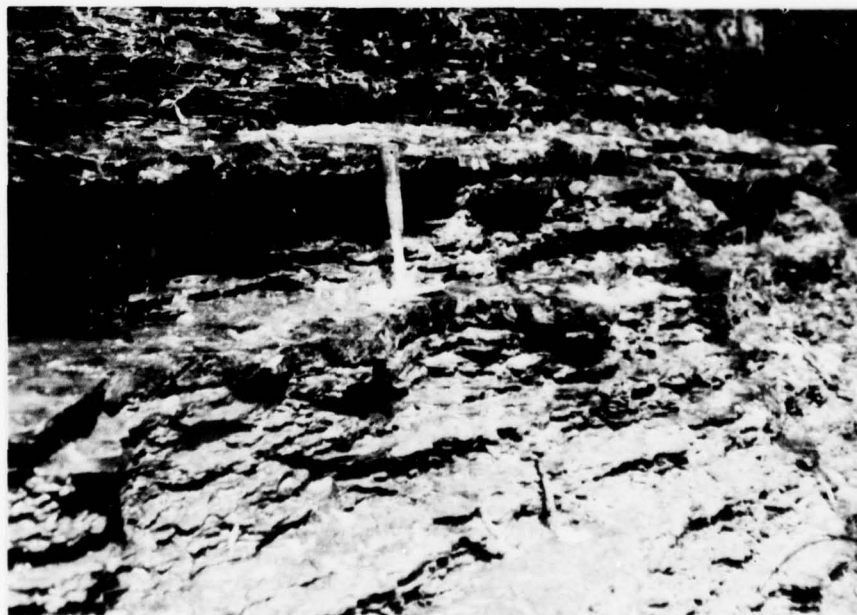
SEEPAGE FROM ROCK LEDGE SHOWN IN ABOVE PHOTO

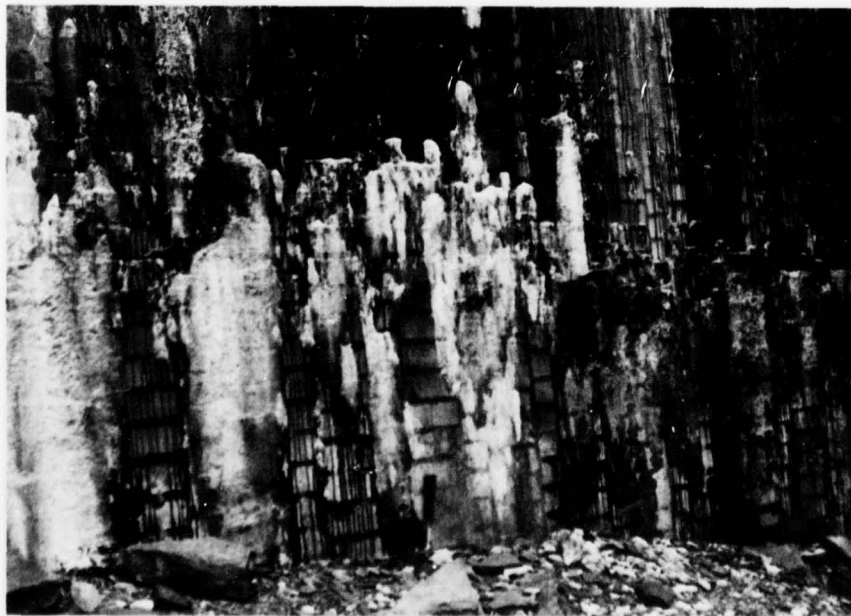
There are numerous areas with white deposits on the downstream face of the dam; deposition of as much as 2 inches thick has been observed. Minor leakage on downstream face of dam appears to be along horizontal and vertical joints of brickwork.

CLOSEUP OF BASE OF DOWNSTREAM FACE SHOWING BRICK FACING
AND MINERAL DEPOSITION DUE TO SEEPAGE

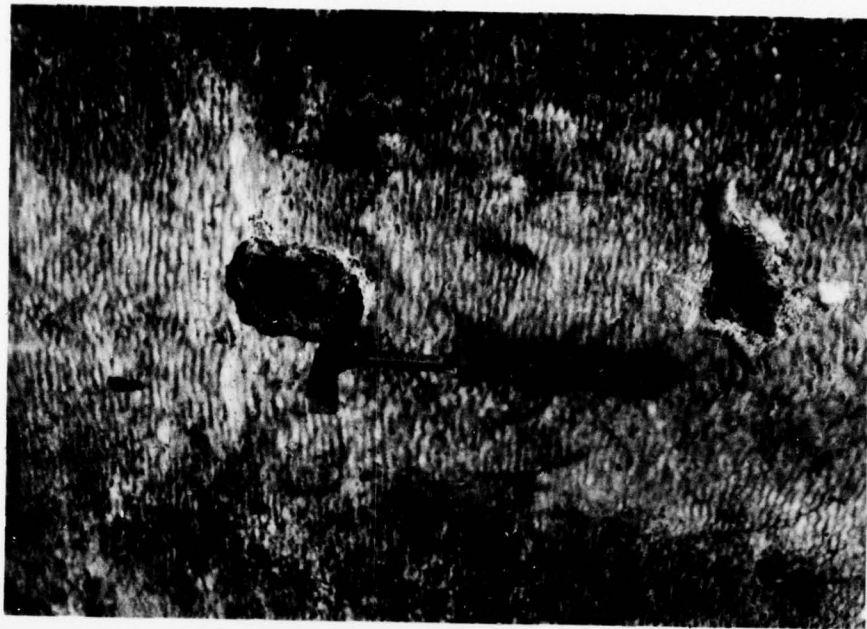
DETAIL, SHOWING THICKNESS OF DEPOSITION
ON DOWNSTREAM FACE OF DAM
